# The Meter Setter

## The Unexpected . . .

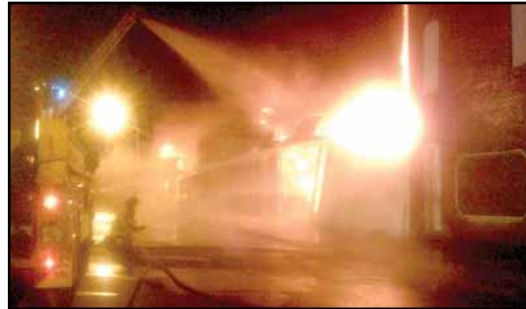
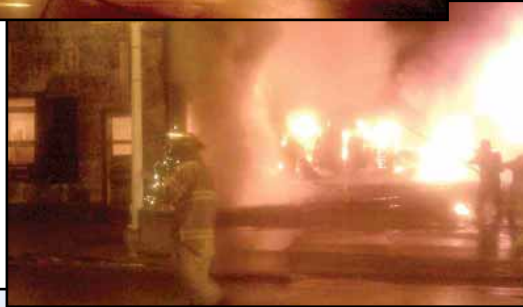
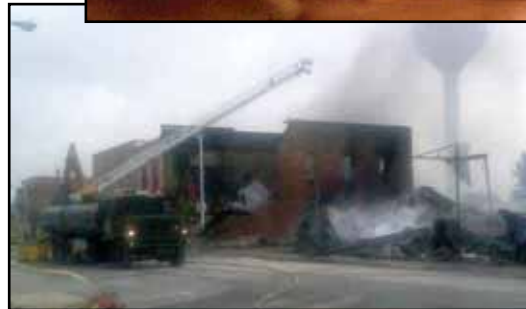
*Smart phone photos compliments of Bill Miller, Miller's Body Shop .*

the blaze, taxing the water system to the extreme. Below-freezing temperatures for the first cold snap of the winter, together with the stress of fighting the fire, led to the split of a four-inch cast iron water main.

The battle against this massive fire, combined with the main break, quickly drained about 350,000 gallons of water from the elevated storage tank in Keota. Facing the possible loss of the town's minimum water supply needs, firefighters began to haul water with tanker trucks from a neighboring community.

To Keota Public Works' credit, they had the repair clamp in stock and quickly repaired the main with a Ford Meter Box FS1-514 x 30 repair

clamp. Another leak sprung up a few hours later, but a Ford FS1-514 x 24 was waiting on the shelf to repair that leak.
