FORD / UNI-FLANGE® INTRODUCES SERIES 1300-CAS MECHANICAL JOINT REPAIR KIT FOR DUCTILE IRON AND C900 PVC PIPE

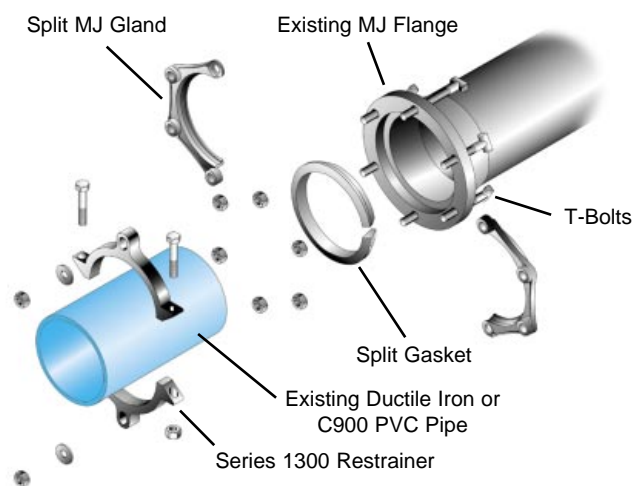
Exploded view of the UFR1300-CAS

The new Uni-Flange® Series 1300-CAS Mechanical Joint Repair Kit addresses special needs encountered while installing new lines or repairing leaking joints that require restraint. The Uni-Flange® Mechanical Joint Repair Kit, UFR1300-CAS, is designed to repair leaks in existing mechanical joint installations. The two-piece gland and split gasket provide for easy installation on Ductile Iron or C900 PVC pipe. The UFR1300-CAS combines the ability to repair leaks with reliable thrust restraint on the existing joint.

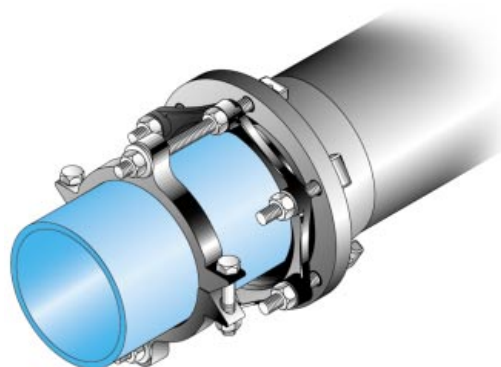
Assembled view of the UFR1300-CAS
